## **Preliminary Report**

**Accident involving Air India's B787-8 aircraft bearing registration VT-ANB  
at Ahmedabad on 12 June 2025**

**Government of India  
Ministry of Civil Aviation  
Aircraft Accident Investigation Bureau**

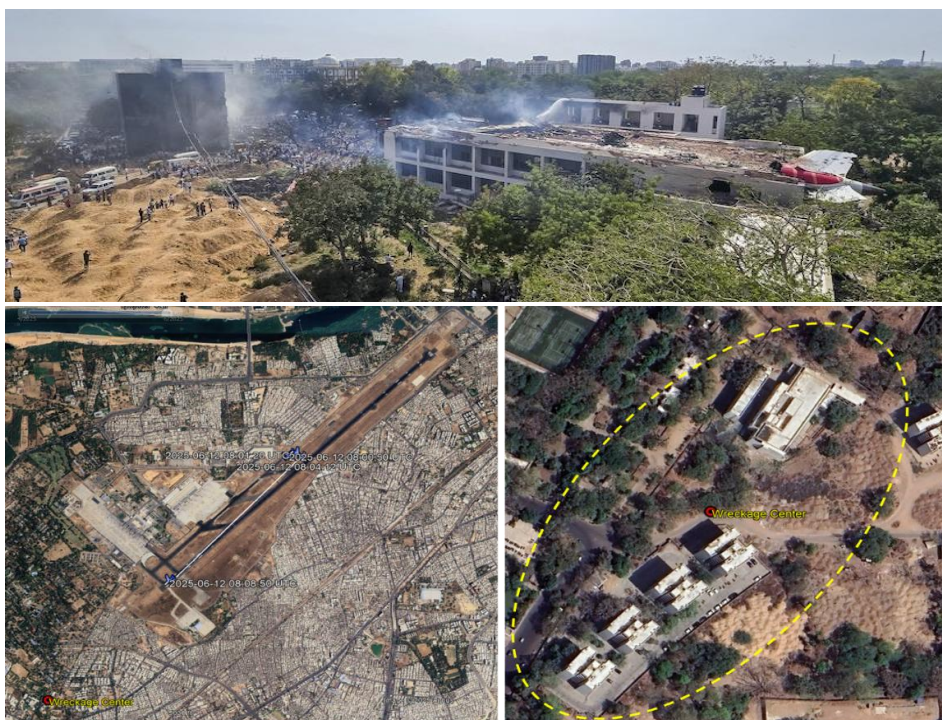
Figure 1 Accident Site with respect to airport (left) and debris field

The Aircraft was destroyed due to impact with the buildings on the ground and subsequent fire. A total of five buildings shown in the figure below were impacted and suffered major structural and fire damages.

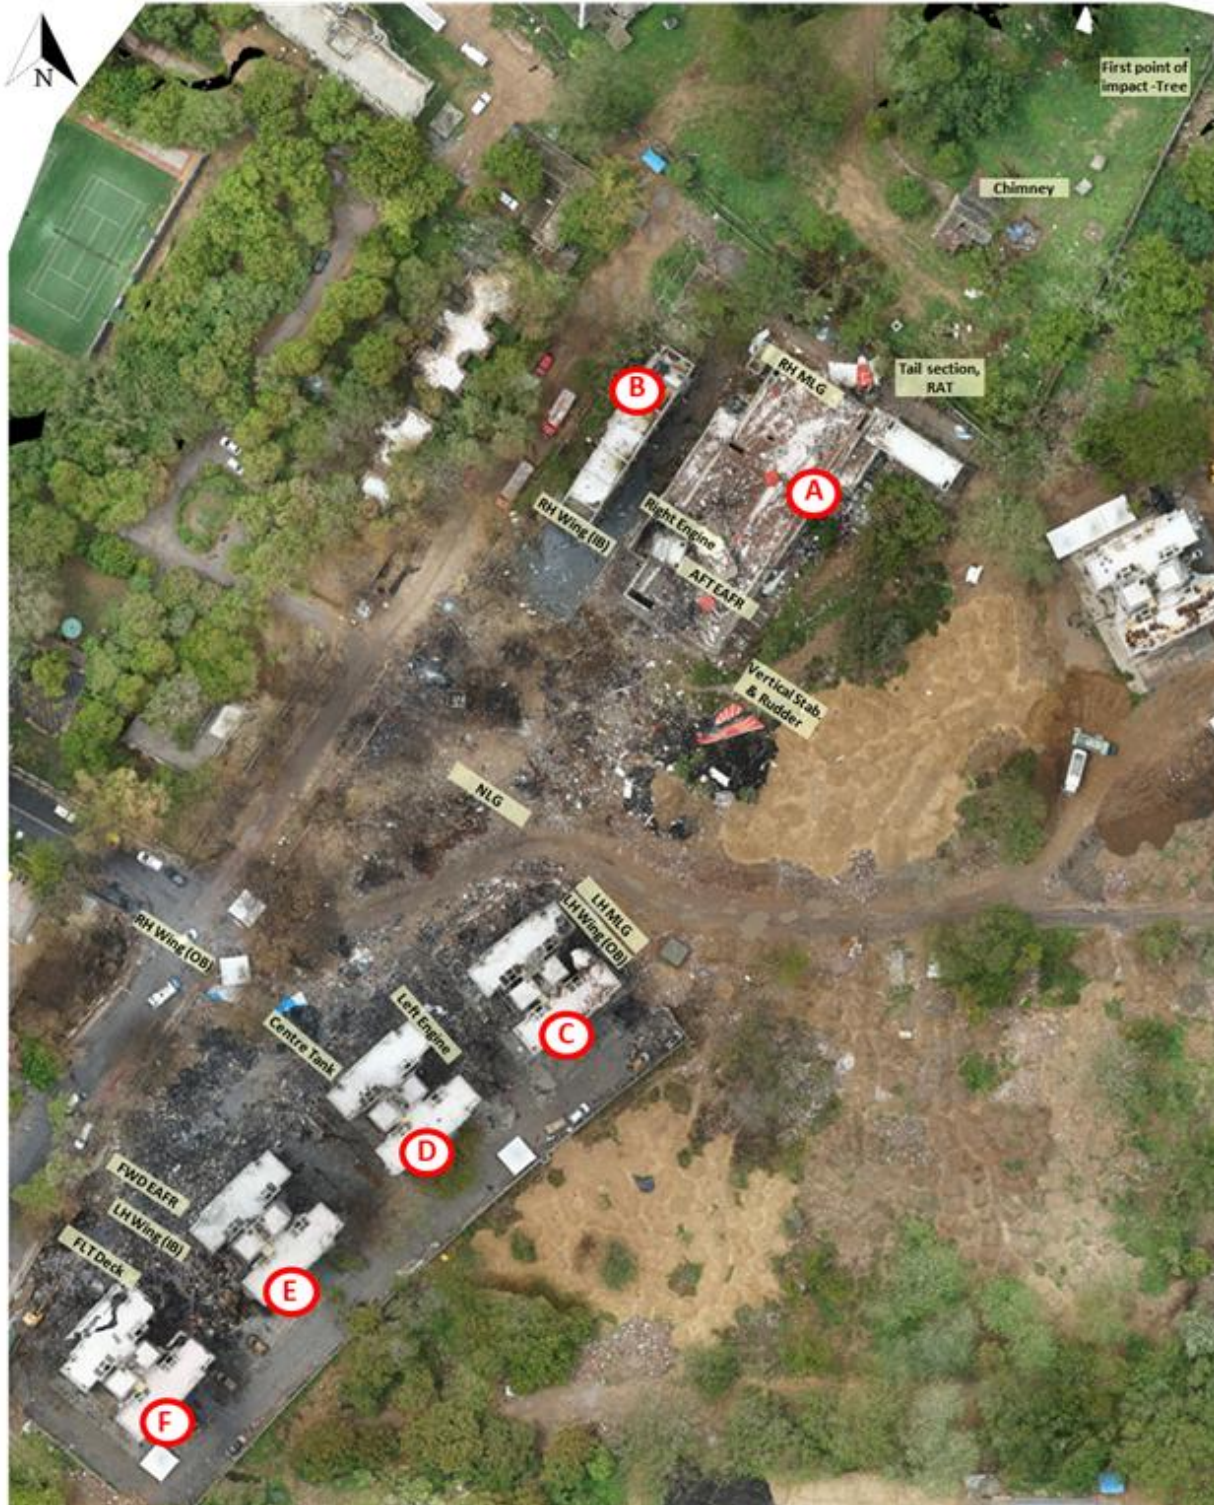
Figure 2 Wreckage layout

After takeoff, the aircraft impacted the BJ Medical College hostel which is 0.9 NM from the departure end of Runway 23. The Emergency Locator Transmitter (ELT) was not activated during this event. The wreckage, from the first impact point till the last identified aircraft item, was distributed in an area of approx. 1000 ft \* 400 ft. A layout of the crash site has been given in Fig. 2 indicating the significant parts of the aircraft. The buildings at the wreckage site have been labelled alphabetically from A-F in the layout for easy reference.

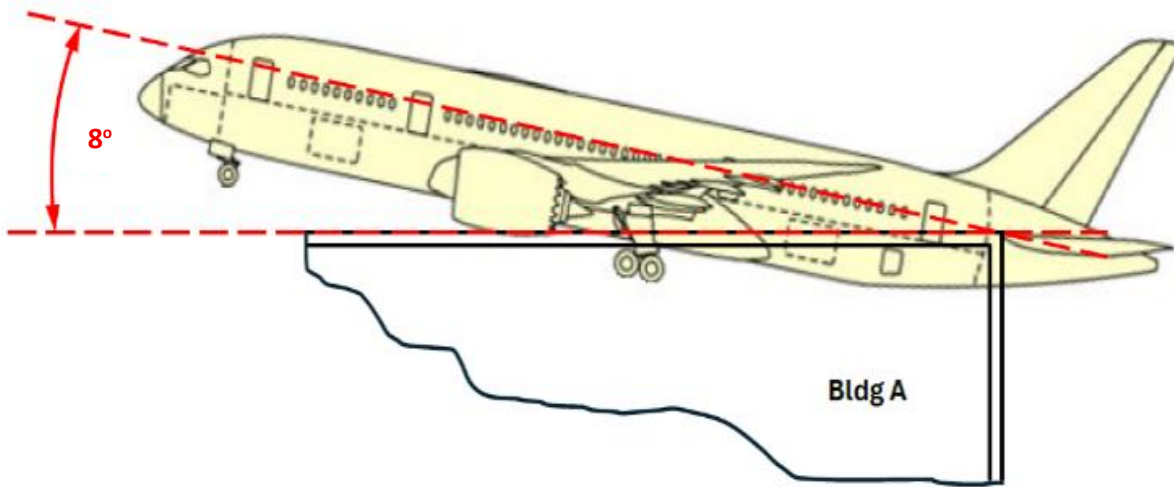
Figure 3 Aircraft attitude at the time of impact with Building A

As the aircraft was losing altitude, it initially made contact with a series of trees and an incineration chimney inside the Army Medical Corps compound before impacting the northeast wall of the Building A. The distance between the tree on which the aircraft made its initial contact and the point on the Building A where the aircraft impacted is 293 ft. As the

aircraft moved forward, it continued fragmenting and collided with other structures and vegetation. The impact witness marks on the building and airplane indicated a likely nose-up attitude (about 8°) and wings level.

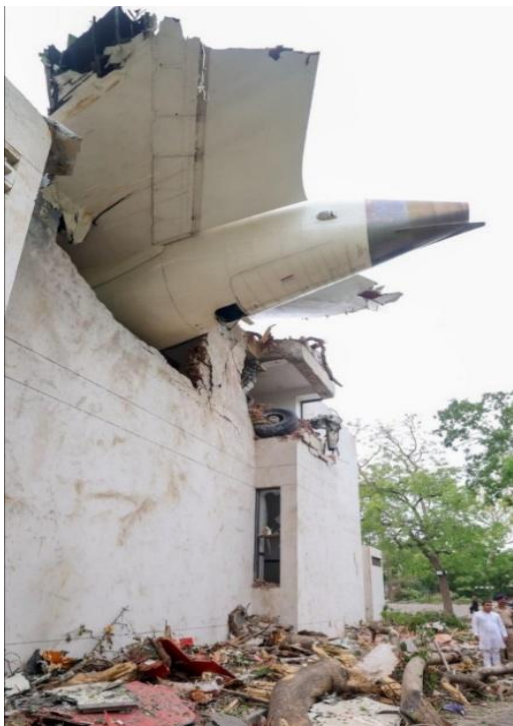
Figure 4 Tail section & RH MLG embedded in the building A

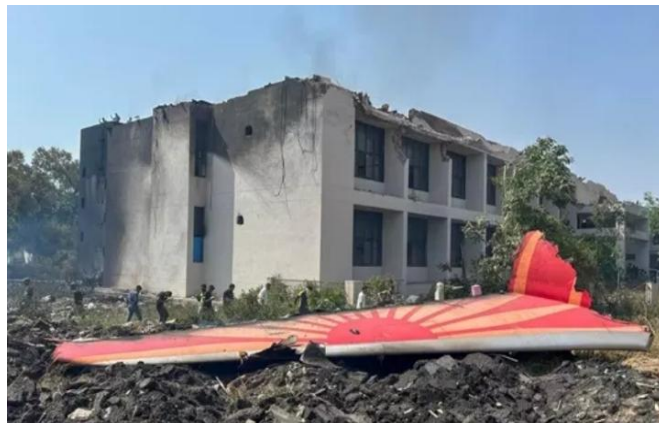
Figure 5 Vertical Stabilizer adjacent to Building A

The vertical stabilizer (*fig. 5*) separated from the aft fuselage and came to rest about 200 feet south of the initial point of contact with the Building A. The tail section and the RH Main Landing Gear (MLG) of the aircraft were found embedded in the northeast wall of the Building A while the rest of the airplane continued its forward movement.

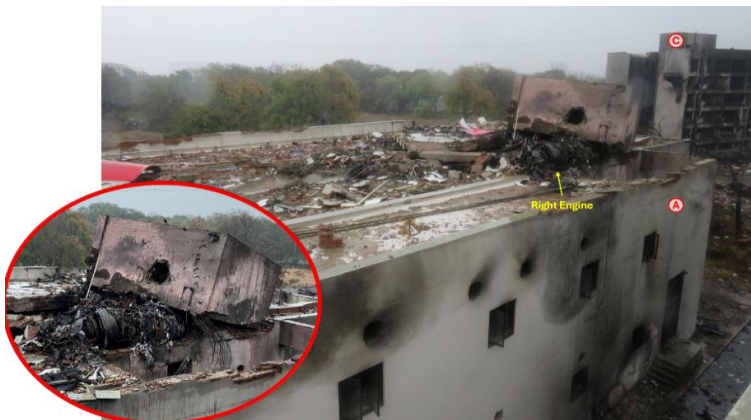
Figure 6 RH Engine

As the airplane continued its path across the roof of the Building A the right engine (*fig. 6*) struck the concrete water tank structure, separated from the airplane and rested underneath the water tank structure facing a heading of approx. 226 degrees near south-west wall of the Building A.

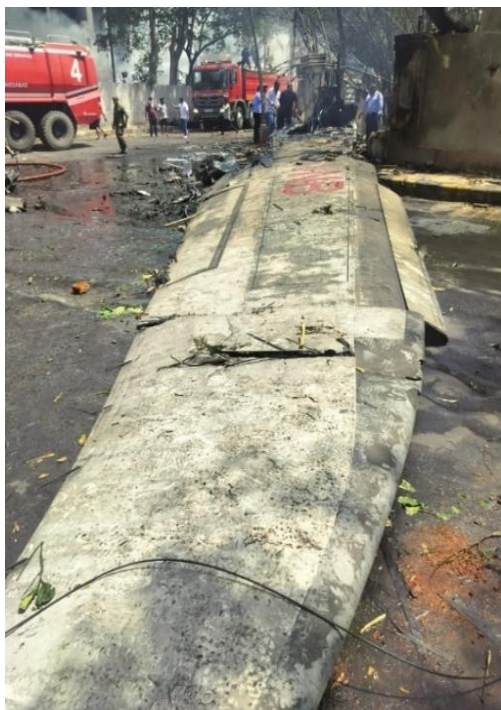
Figure 7 : RH Wing Outboard

The right-wing mid-section and the outboard section (*fig.7*) was about 280 feet and 520 feet southwest respectively from the initial point of contact with the Building A.

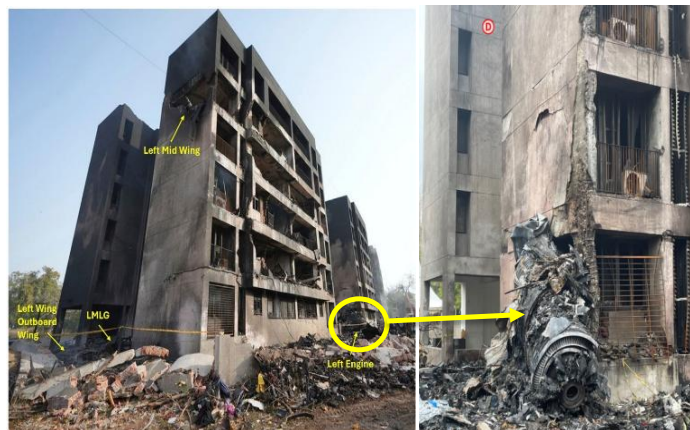
Figure 8 LH Engine

The left engine (*fig.8*) got separated from the airplane and struck the north corner of Building D at the ground level where it remained and was roughly perpendicular to the right engine resting position, at heading of approx. 326 degrees. The wall was pushed into the

building and the northwest building column was damaged such that portions of the concrete

were missing and exposing the internal metal rebar. The engine, remaining portions of attached cowlings, and the surrounding area were heavily damaged by fire.

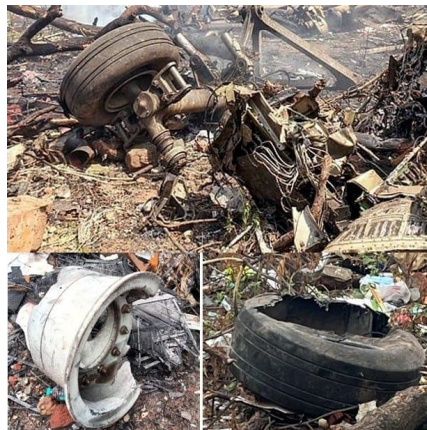
Figure 9 Nose Landing Gear

The nose landing gear (NLG) (*fig. 9*) was found on the ground about 307 feet southwest from the initial point of contact with Building A.

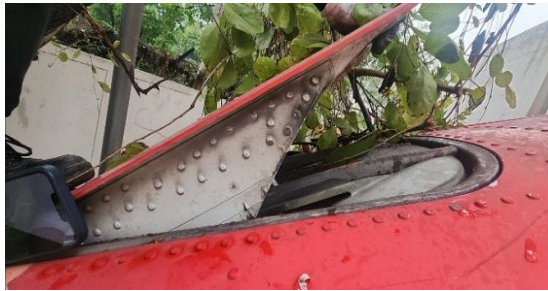
Figure 10 APU Air Inlet Door

After the tail section was brought down, the APU was inspected and found intact inside the APU compartment. The APU air inlet door (*fig. 10*), which was intact, was found open. The fuselage fragmented and sustained thermal damage as it traveled along the northwest faces of Buildings C, D, E, and F with the furthest debris observed at about 765 feet southwest from the initial point of contact with building A. The flight deck area and windshield support structure came to rest at about 650 feet southwest from the initial point of contact with Building A.

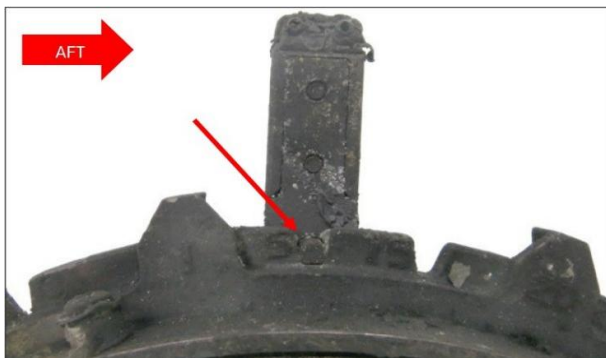
Figure 11 Flap Handle Lever

The flap handle assembly (*fig.11*) sustained significant thermal damage. The handle was found to be firmly seated in the 5-degree flap position, consistent with a normal takeoff flap setting. The position was also confirmed from the EAFR data. The landing gear lever was in “DOWN” position. (*fig.12*)

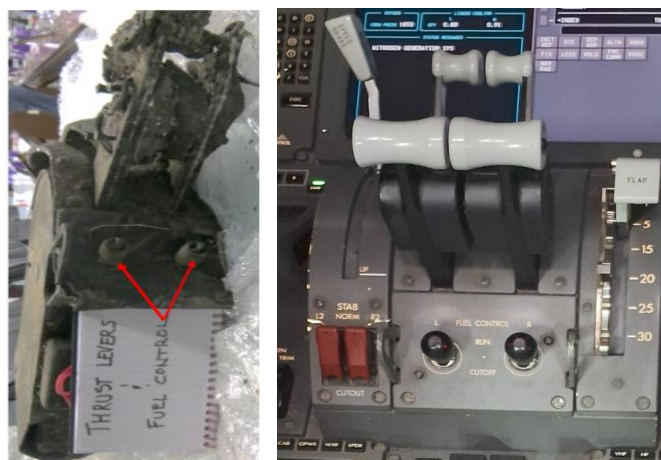
Figure 13 Thrust Lever Quadrant & Fuel Control Switch

The thrust lever quadrant sustained significant thermal damage. Both thrust levers were found near the aft (idle) position. However, the EAFR data revealed that the thrust levers remained forward (takeoff thrust) until the impact. Both fuel control switch were found in the “RUN” position. (*fig.13*) The reverser levers were bent but were in the “stowed” position. The wiring from the TO/GA switches and autothrottle disconnect switches were visible, but heavily damaged.

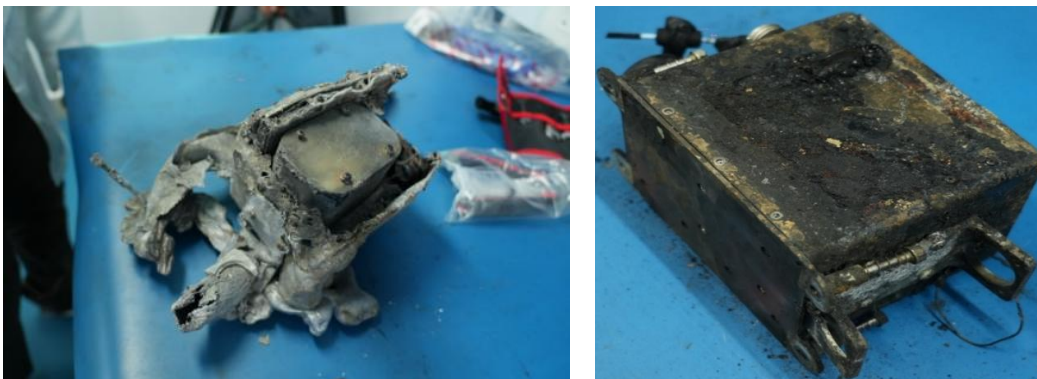
Figure 14 EAFR AFT & FWD

The aft EAFR was located on the roof top of Building A on 13<sup>th</sup> June 2025. The EAFR had impact and thermal damages to the housing. The wires were protruding from the housing and the connectors were burnt.

The forward EAFR was located on 16<sup>th</sup> June 2025 from the wreckage debris besides the Building F. The EAFR was burnt and covered in soot. The EAFR was still attached to the

equipment shelf with part of the connector melted but still connected. The ULB was still connected to the housing and the lithium battery was also attached to the equipment shelf, which was removed later prior to transportation.

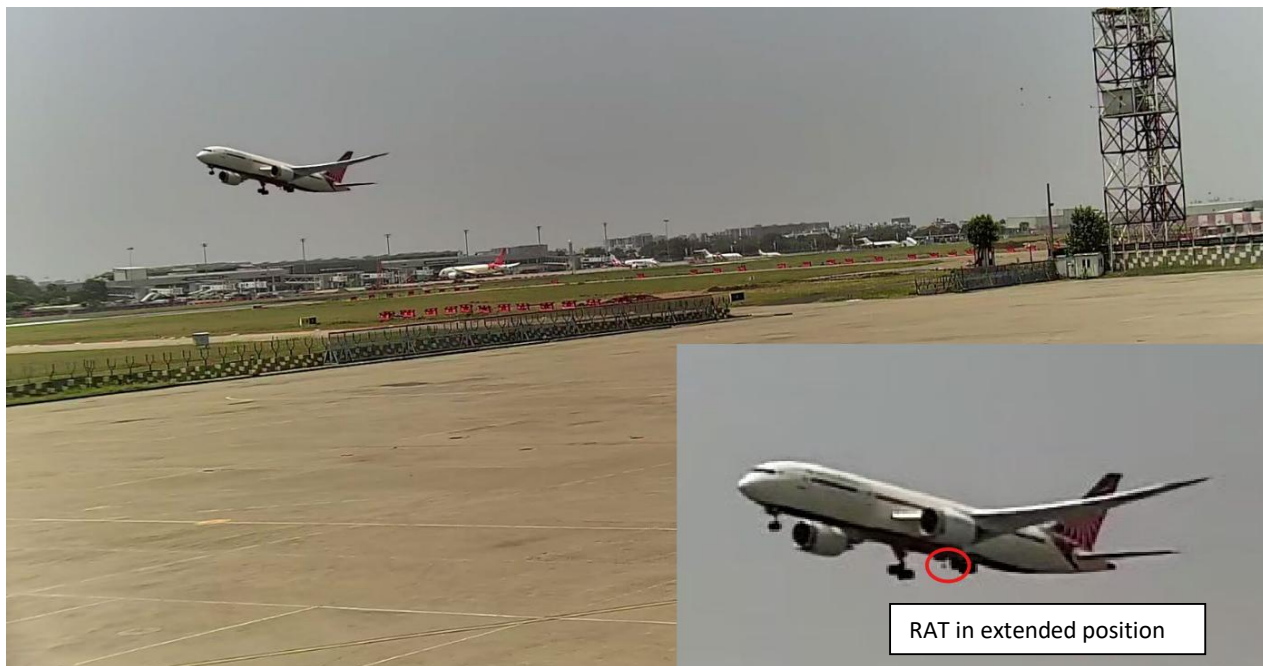
Figure 15 CCTV screenshot of RAT Deployment

The CCTV footage obtained from the airport showed Ram Air Turbine (RAT) getting deployed during the initial climb immediately after lift-off (*fig. 15*). No significant bird activity is observed in the vicinity of the flight path. The aircraft started to lose altitude before crossing the airport perimeter wall.
